South African Civil Aviation Authority

SERIOUS INCIDENT

Probable Cause					
<p>During the take-off roll the captain applied an improper rotation technique by referencing the Side Stick Order Indicator to the 9° position on the Primary Flight Display. This caused the aircraft to de-rotate and not to lift-off as expected. When the aircraft over-ran the end of the runway with the associated noise, the aircraft was rotated further and became airborne with the application of Take-Off/Go-Around thrust.</p> <p>The training and mindset of the pilots could be considered as a significant contributory factor to this incident. They were "programmed" by tailstrike avoidance information, aircraft difference information and certain expectances to perform the way they did.</p> <p>A further contributing factor to the cause of this incident could be considered as the differences in take-off performance of the different Airbus aircraft of the operator's fleet.</p> <p>A further contributing factor to the cause of this incident was that this was both flight crew members second flight in the actual aircraft of this variant of the Airbus A340 (Captain's first flight as pilot flying).</p>

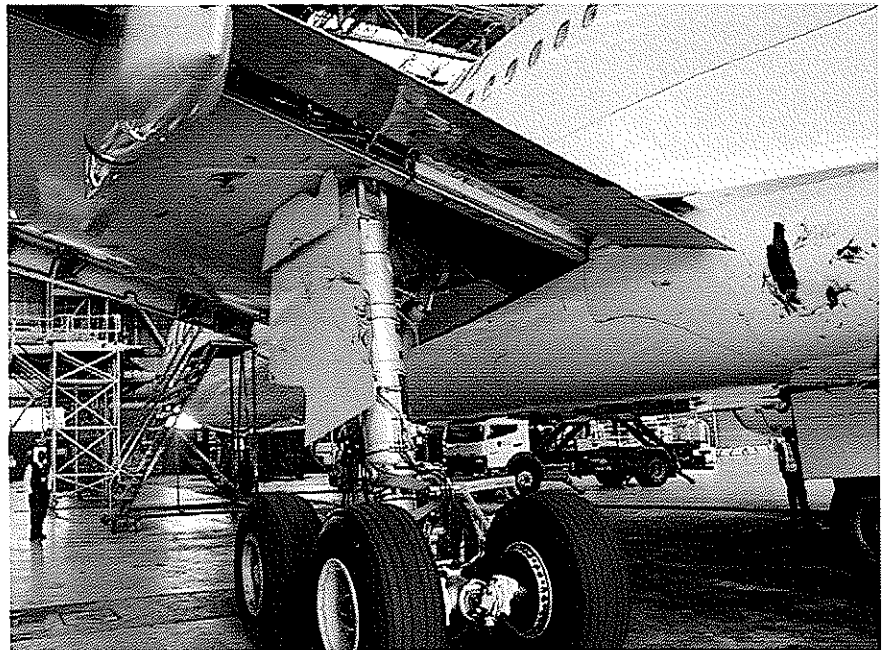
1.3.1 The aircraft's tyres suffered damage during the overrun when the wheels impacted the runway end lights and light plinths. The tyre debris impacted the lower fuselage in the area of the main and centre landing gears. A flap drive shaft directly above the right-hand main landing gear was

sheared and a piece of tread penetrated a panel directly above the left main landing gear, leaving a hole, approximately 10cm by 15cm in the upper surface of the left wing. Both flaps and other portions of the fuselage were damaged. The pressure hull of the aircraft was not penetrated, but debris left a large hole in the rear left wing-to-body fairing. There was extensive secondary damage of various components, plus dents and rub marks over the whole of the rear fuselage.

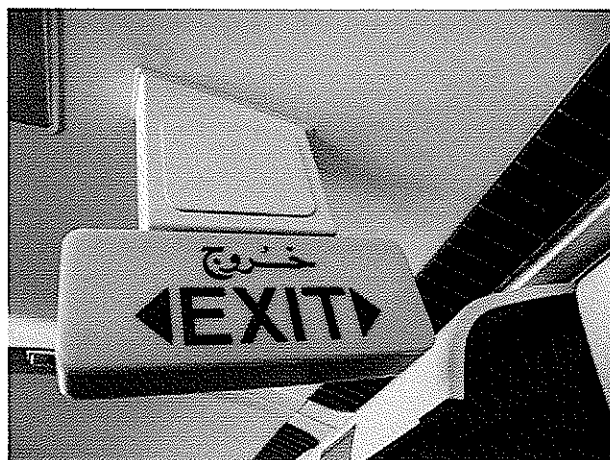
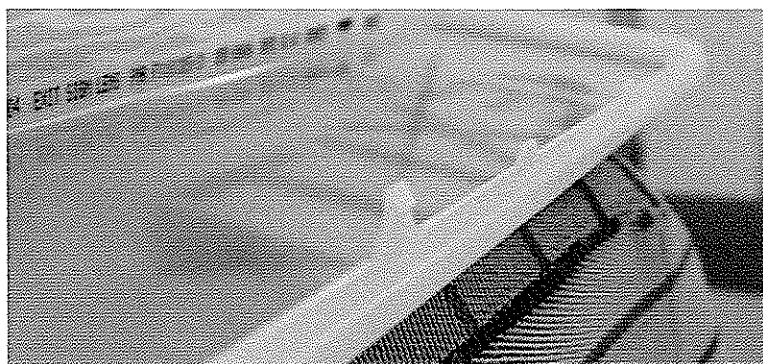
The cabin crew reported that during the landing with the damaged tyres the lenses of several of the lights came adrift and fell to the passenger cabin's floor. The investigator inspected a similar aircraft of the operator (A6-ERM) and

found that the fittings on the doorframes were more rigid than the fittings that were hanging from the ceiling of the passenger cabin. To remove the lenses of these lights, the lens are pulled either at the upper or lower side of the lens, away from the fitting and the retaining lugs would disengage releasing the lens. The investigator observed one of the lenses fitted to the fitting hanging in the cabin area was not properly attached to the fitting at the top. Feeling the tightness of the fit of the other lenses for security, it was observed that 8 lenses fitted snugly to the light fittings and 7 lenses could be removed from the light fittings by applying a much smaller force. When the light fittings fitted to the cabin's ceiling were tapped with an certain intensity the lenses came adrift.

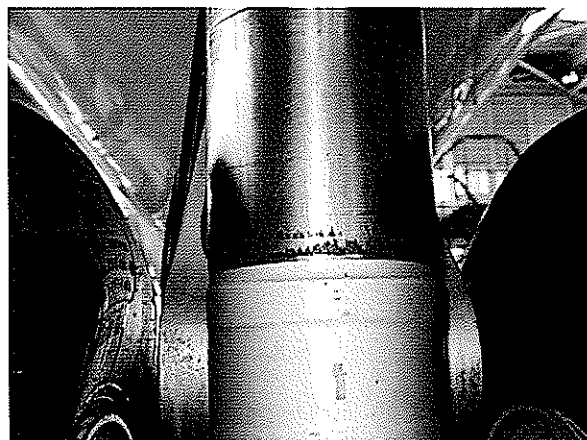
When the first officer executed the walk-around inspection before the flight he noticed that the nose landing gear oleo was totally compressed. The grease mark left on the surface of the oleo leg was an evidence of this (refer to photograph). He enquired about this from the ground engineer and was informed that the forward cargo hold was loaded and the rear cargo hold was still being loaded.

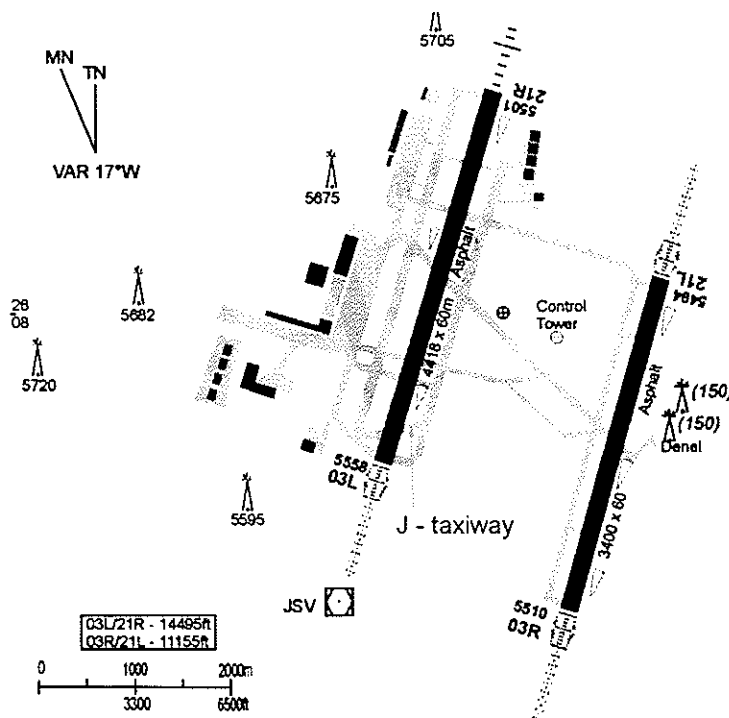
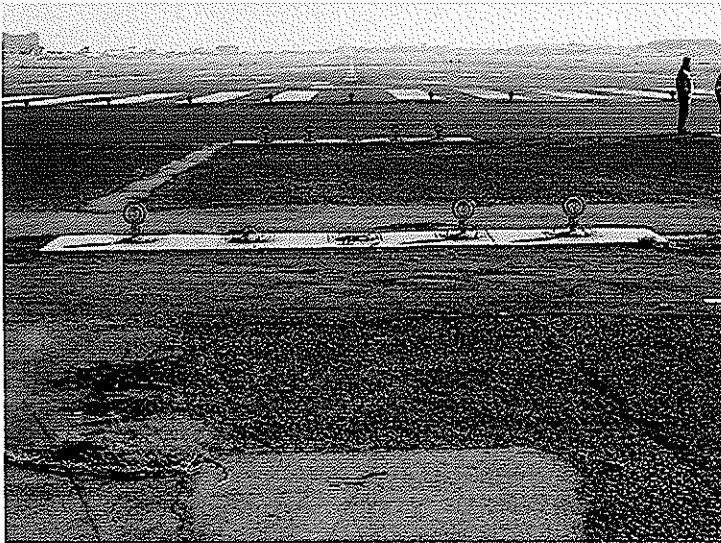
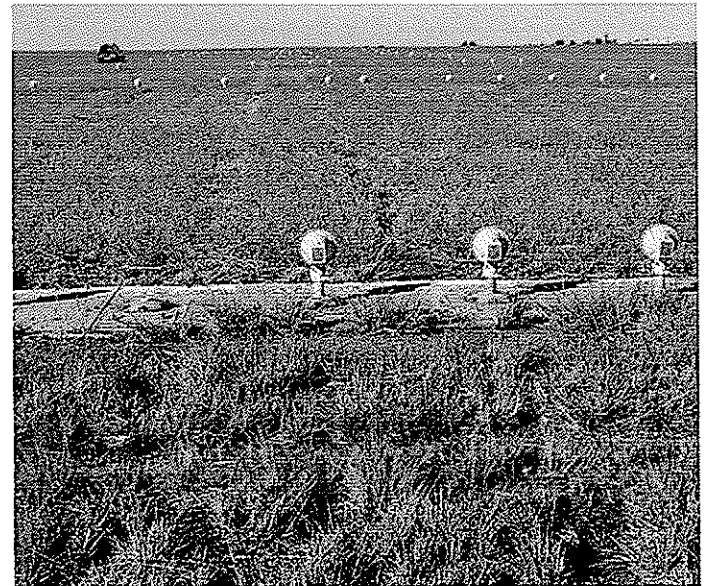
1.10.2 The aircraft overran the end of Runway 21R and damaged twenty five of the runway end/approach lights of Runways 21R and 03L. The initial area at the end of Runway 21R is an area covered with asphalt. This area proceeds in the runway direction from the end of the runway where the end lights were situated to the third row of lights. From there onwards the area was covered with grass and the rows of approach lights were mounted on concrete plinths.

1.10.3 It was noted during the incident investigation that although the plinths appeared to be level with the grass area, that the soil on the edges of some of the plinths were eroded away to such an extent that it exposed a step on the side of some of the plinth of up to 50 mm. These edges were considered contributory to the tyre damage. Although one does not expect aircraft wheels to roll over this area, it does present a safety hazard as this incident proved.

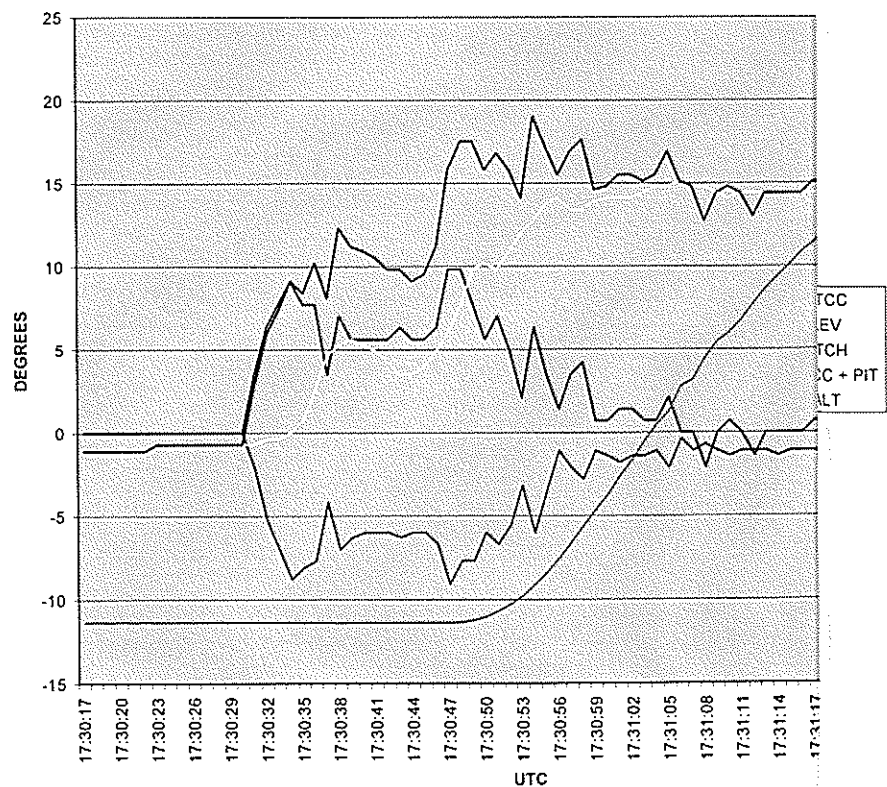
One can determine from the graph that the pilot started up at

17:30:31 during the take-off run. Approximately a second later the aircraft started to pitch the nose upwards. Eight seconds after the initial stick input the aircraft reached a maximum pitch angle and then the aircraft started pitching down again and reached a minimum pitch angle approximately four seconds later. By referring to the graph representing the sum of the pitch control and pitch attitude it suggests that after the side-stick was moved to approximately the nine degree position at 17:30:35 it was held in that proximity until 17:30:45 when the angle was suddenly increased dramatically. From this time onwards the pitch angle started increasing again and the aircraft lifted off seventeen seconds after the initial side stick input.

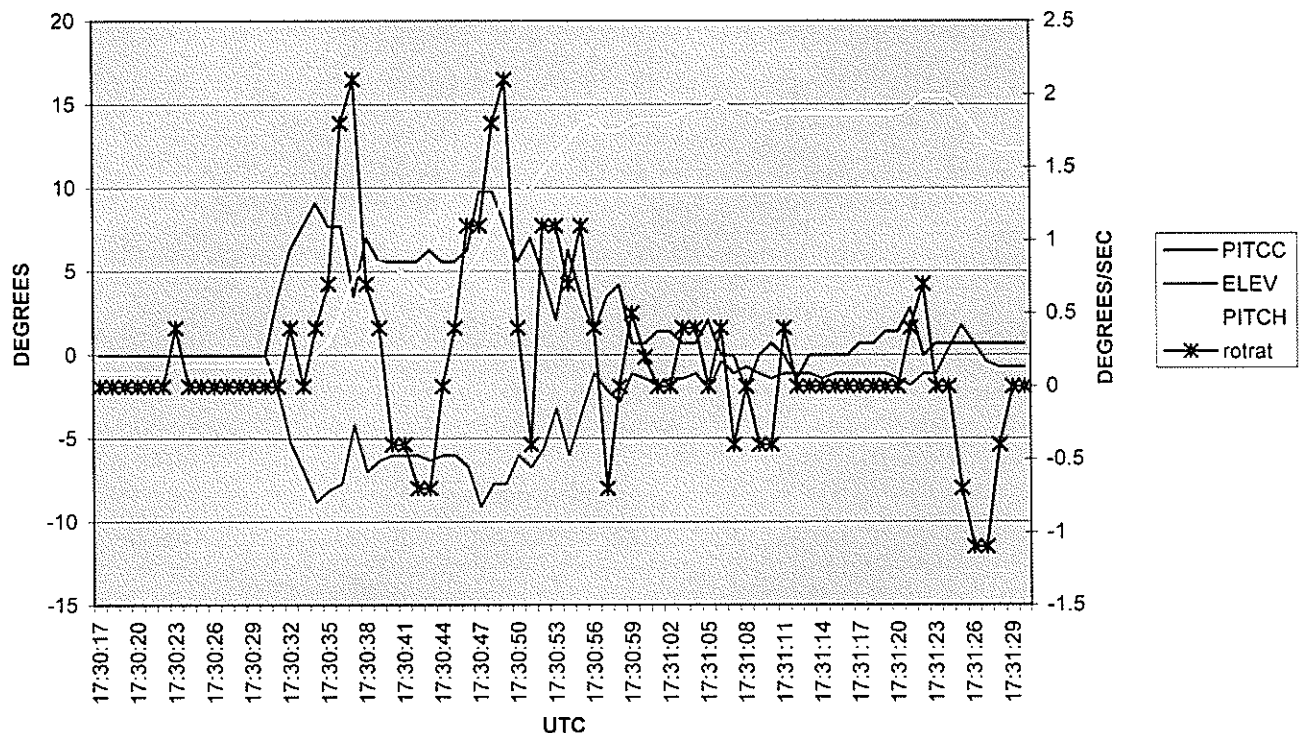
Considering these graphs one can conclude that there was an initial rotation rate and with the slackening off of the rearward movement on the sidestick the rotation rate became negative where after it increased again until the aircraft took-off.

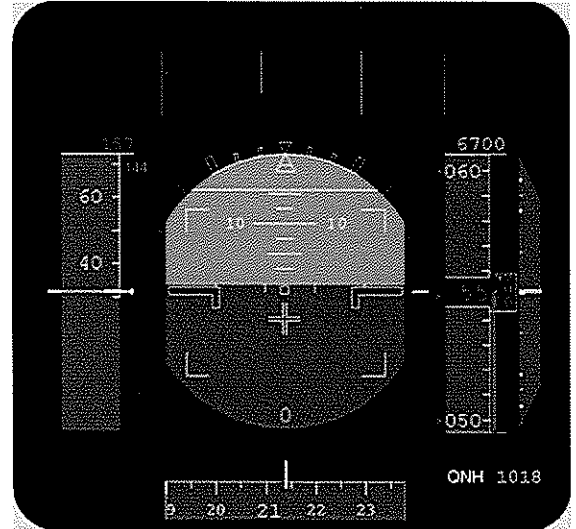
1.11.8 The manufacturer's safety section used an animation program to represent the Primary Flight Display for the take-off sequence. This animation was forwarded to the investigator-in-charge and this animation assisted in visualising the events as it occurred. The movement of the SSOI is observed until the stage where the aircraft is rotated and become airborne. The first event was the forward application of the sidestick at 32 knots and the associated movement of the SSOI to below the horizon display.

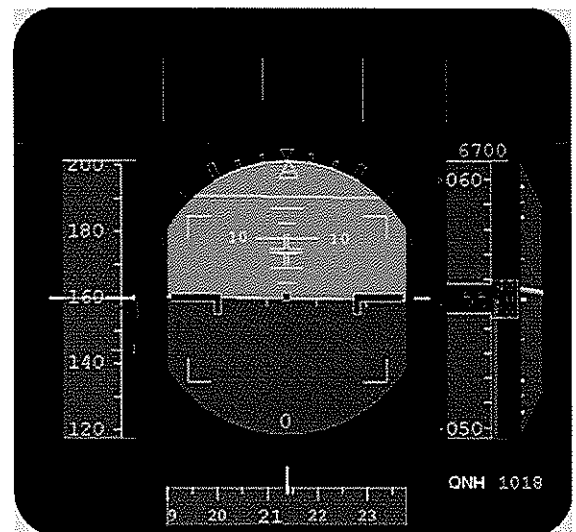
1.11.9 The next event observed is when the pilot moved the sidestick backwards for the aircraft to rotate at V_R . One can observe that the SSOI moved up to a position in the region of or are on the way to the 9° position above the horizon display on the primary flight display.

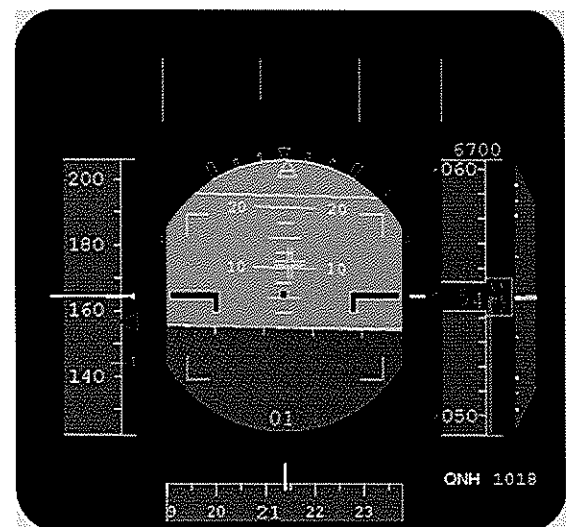
1.11.10 As the nose of the aircraft moves up during the rotation of the aircraft one can observe that the pilot attempt to maintain the SSOI in the region of the 9° position on the horizon display. The problem however was that with the rotation of the aircraft the horizon display has moved downwards and thus the 9° position on the horizon display too. One observe that the nose of the aircraft lower during this action.

1.11.11 Seconds after the pitch angle had decreased a sudden increase in backwards movement of the sidestick is observed when the SSOI moves upwards on the display. At this time one observe

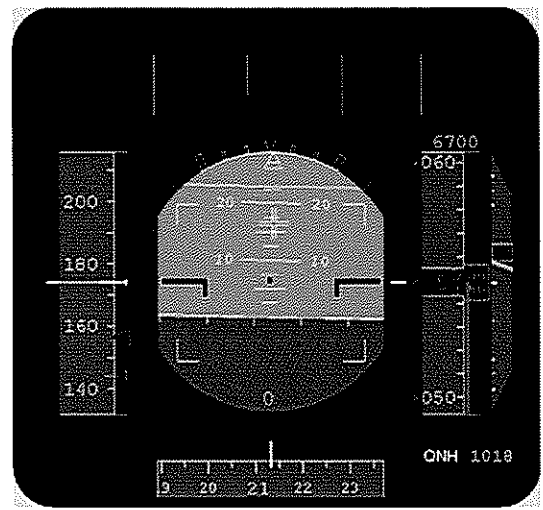
a positive rate of climb indication on the rate of climb indicator to the right-hand of the display and the SSOI disappear from the display when the aircraft become airborne and change to the flight mode.

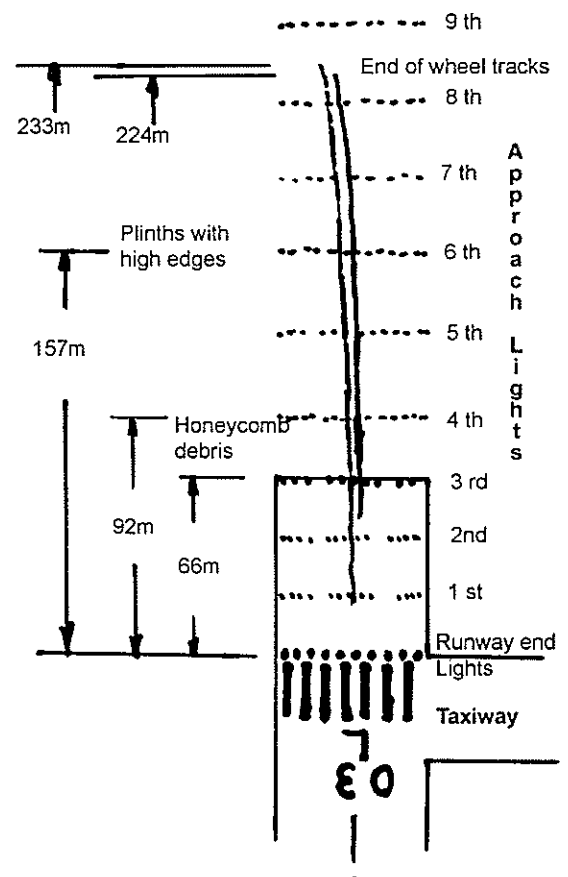
The aircraft departed the runway at the threshold of Runway 03L. The wheels impacted the runway end lights of Runway 21R and then the approach lights of Runway 03L, a total of twenty-five lights. The wheel tracks could be observed on the initial overrun area, which was asphalt covered and then onto the grass covered area. The asphalt covered overrun area ended at the third row of approach lights from the threshold of Runway 03L (66m in length). Large fragments of tyre were recovered in the area of the sixth row of approach lights and it was the plinths of this row of lights that had the high edges. However rubber fragments of the failed tyres were spread over most of the area where the tyre tracks were observed. Smaller fragments of honeycomb structure were recovered in the area of the second and third rows of approach lights. It was thus difficult to predict where the tyres had failed. All the lights fittings were observed to be of the

frangible type. Relating to the DFDR information the aircraft was at a recorded ground speed of approximately 190 knots (351 Km/h) when the tyres impacted with the light fittings.

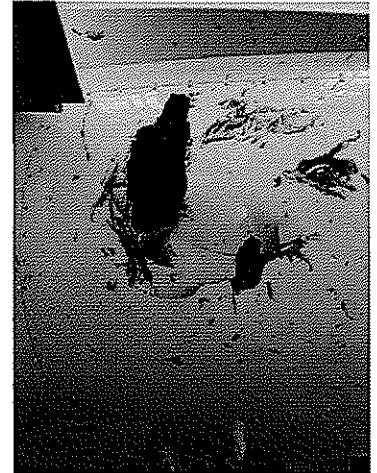
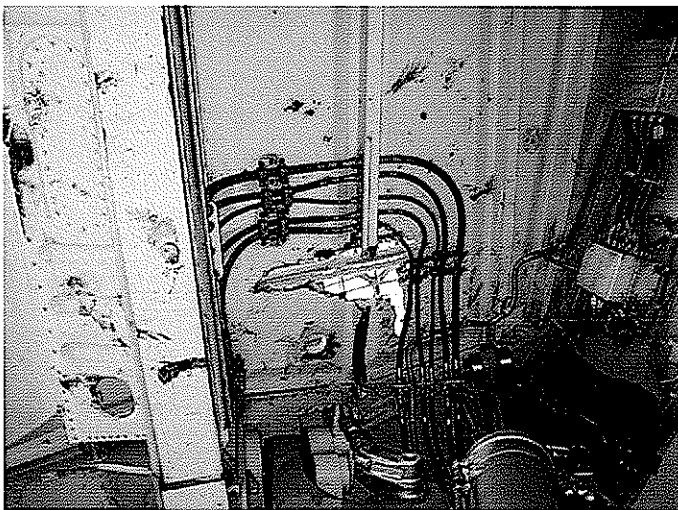
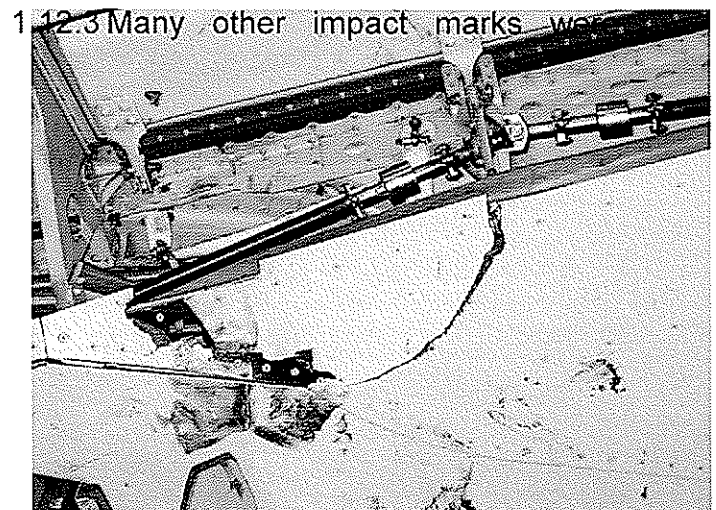
- 1.12.2 All the tyres on the rear wheels on the main landing gear bogies probably failed during the take-off (wheels no's. 5,6,7 & 8). The debris that was thrown from the failed tyres impacted the rear area of the left-hand wing-to-fuselage fairing and punctured a hole of approximately 10cm by 15cm into this fairing. The wing panel above the left-hand main wheel well also suffered a puncture hole and the composite flap drive shaft in the area above the right-hand main landing gear failed due to tyre debris impact. The flap drive shaft failure caused the flap system to detect that the right-hand wing flaps will not retract evenly and it activated the wingtip flap brake to engage in order to prevent an asymmetric flap situation from developing. The pilots became aware of the problem when the defect report on the ECAM system appeared.

observed on the fuselage surfaces, wings and as far as the horizontal and vertical stabilizer, related to tyre fragments contacting the aircraft surfaces during the failure sequence of the tyres.

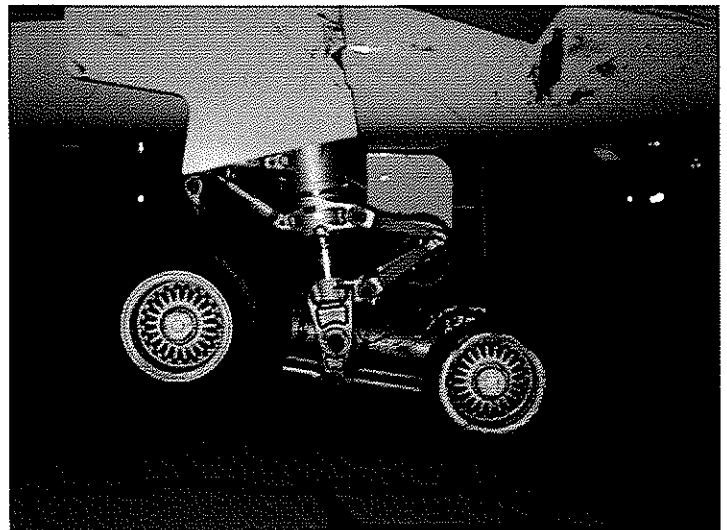
The pilots was initially given the landing runway as Runway 21L, but during the initial approach the surface wind changed and they were vectored towards Runway 03R, which they preferred due to the operational ILS. The first signs of the touch-down point of the aircraft was at approximately 770m from the threshold. Approximately 355m from the touch-down marks one could observe the marks that appear to be the first contact of one of the right-hand main

wheel rims with the asphalt surface of the runway. At 506m from the touch-down point there were marks observed on the runway surface which appeared to be the wheel rim of one of the left-hand main wheels contacting the asphalt surface of the runway. Several such grooves were cut into the runway surface from the starting points mentioned above for the full distance of the aircraft's landing roll to the point where the aircraft came to rest. The aircraft came to rest at 250m from the end of Runway 03R and it could be heard on the ATC recordings how the last few tyres failed. It is estimated that the tyres from three of the forward main wheel (wheels no's: 2,3 & 4) failed at this time.

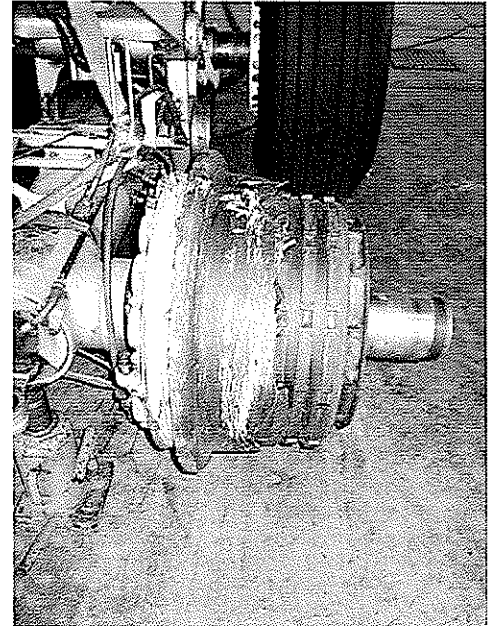
- 1.12.5 The tyre cases of the wheels that failed were totally destroyed down to the wheel rims. The wheel rim of number 8 main wheel suffered a radial failure at the middle of the hub. The maintenance engineer managing the aircraft's repairs was of the opinion that this was possibly due to a severe force of the impact during the take-off run weakening the structure of the hub and the loads imposed on the hub during the landing with the failed tyre caused it to fail. Alternatively the tyre failure caused the bead wire bands to cut into and caused the hub to fail. However it was evident that the outboard segment of the failed hub had moved away from the inner segment and kept on rotating until the aircraft came to rest. The inner segment ceased to rotate when the braking action was applied. It was probably during the time when the outer hub segment moved outboard that the tacho-generator drive was uncoupled as this drive is driven by the outboard segment of the wheel hub (in the wheel cap). It is also probably during the time when the tacho-generator drive became uncoupled that the crew received the number eight brake message.
