An Analysis of MH370's Flight Path Between Waypoints IGARI and VAMPI, a Review of Potential Vulnerabilities Specific to Airplane 9M-MRO and a Hypothesis Regarding Possible In Flight Events and an End-of-Flight Scenario

Mick Gilbert

15 October 2016

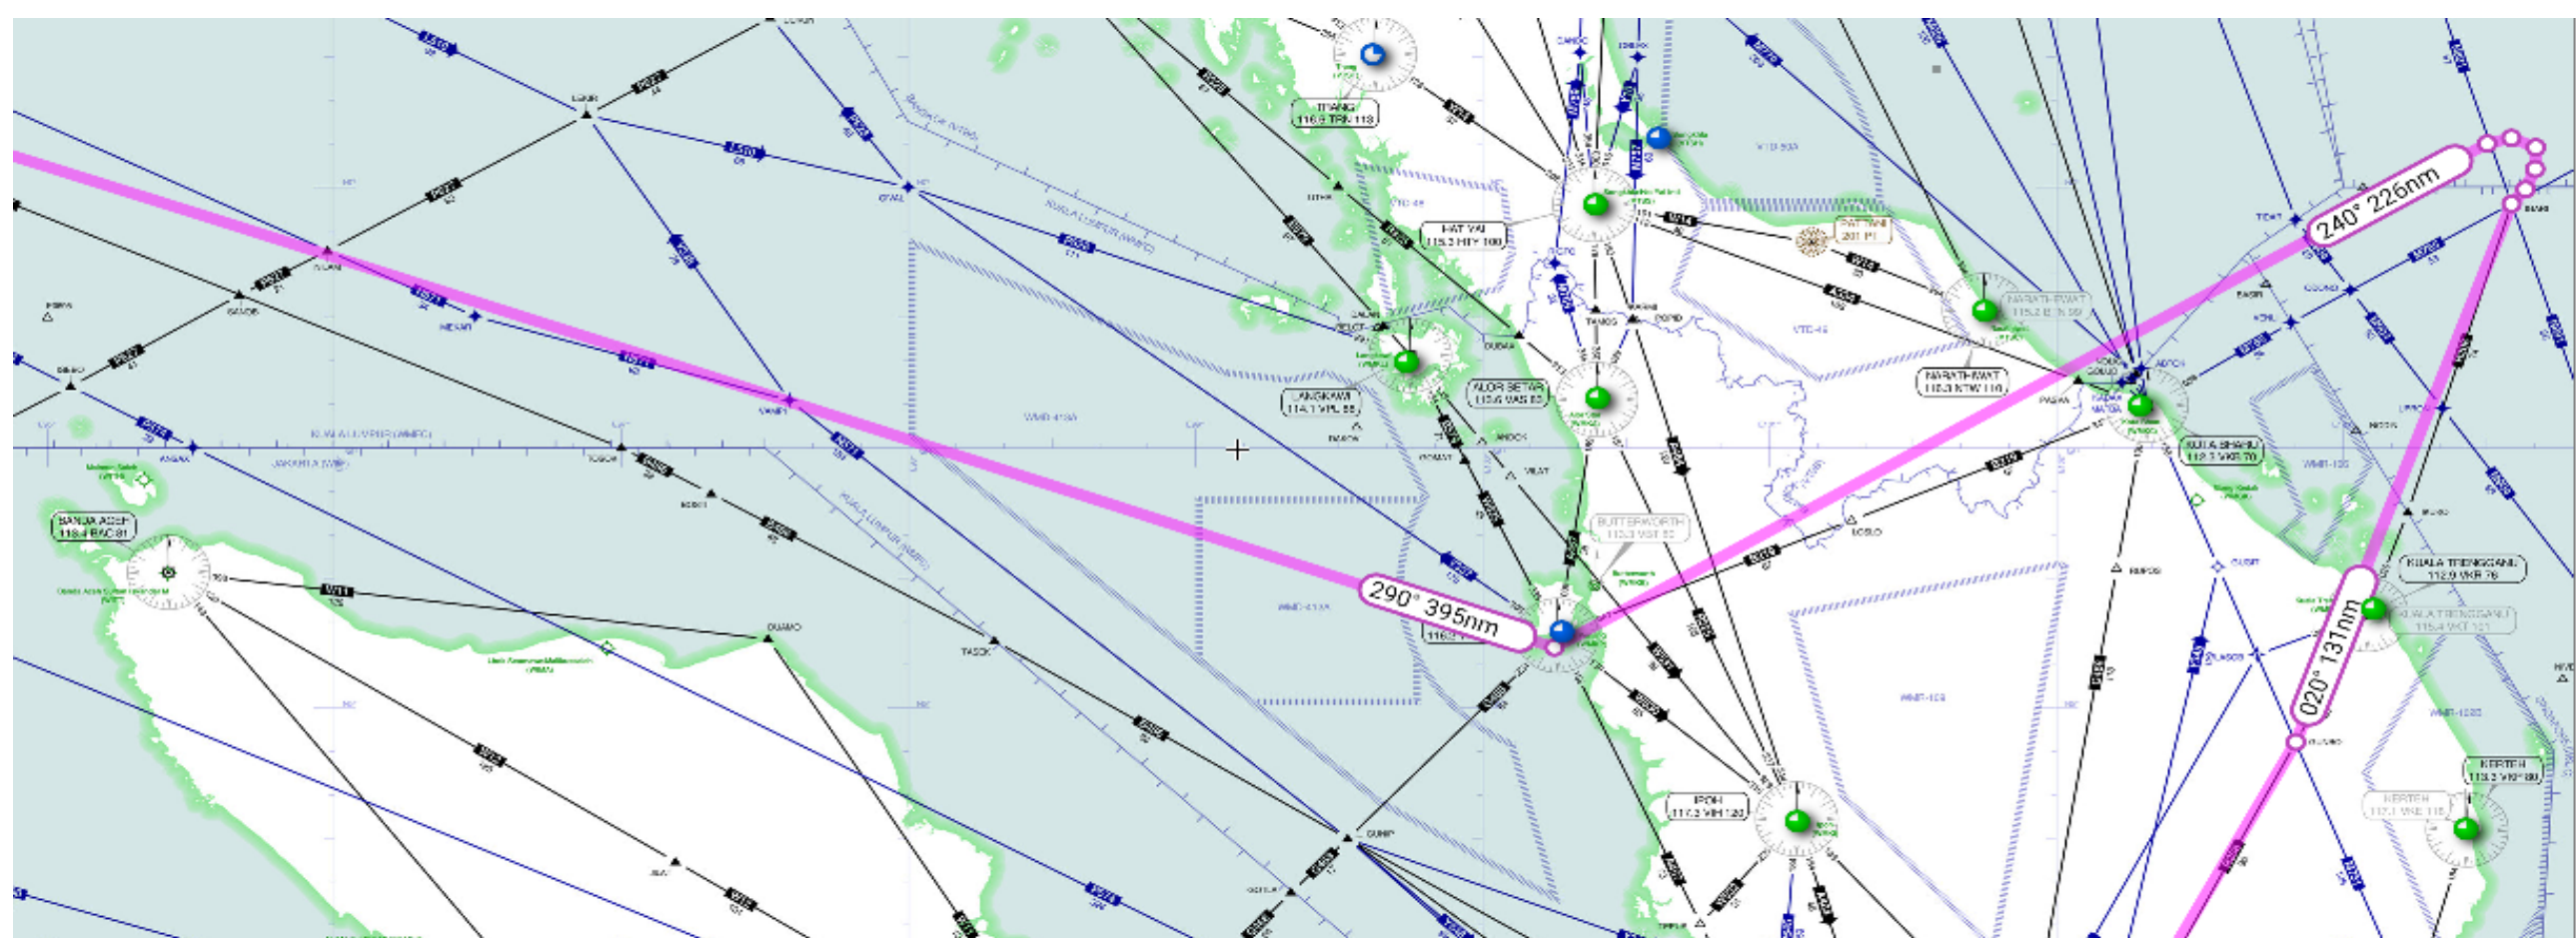
The map below illustrates the very simple course that MH370 flew; an initial right turn at IGARI towards BITOD followed almost immediately by a left turn back towards Penang on a heading of 240°. Then from south of Penang a right turn to 290°; this track would take MH370 over VAMPI and to the north of MEKAR.

In short, the evidence indicates that MH370 may have tracked via one waypoint, VAMPI and I would content that this was coincidental.

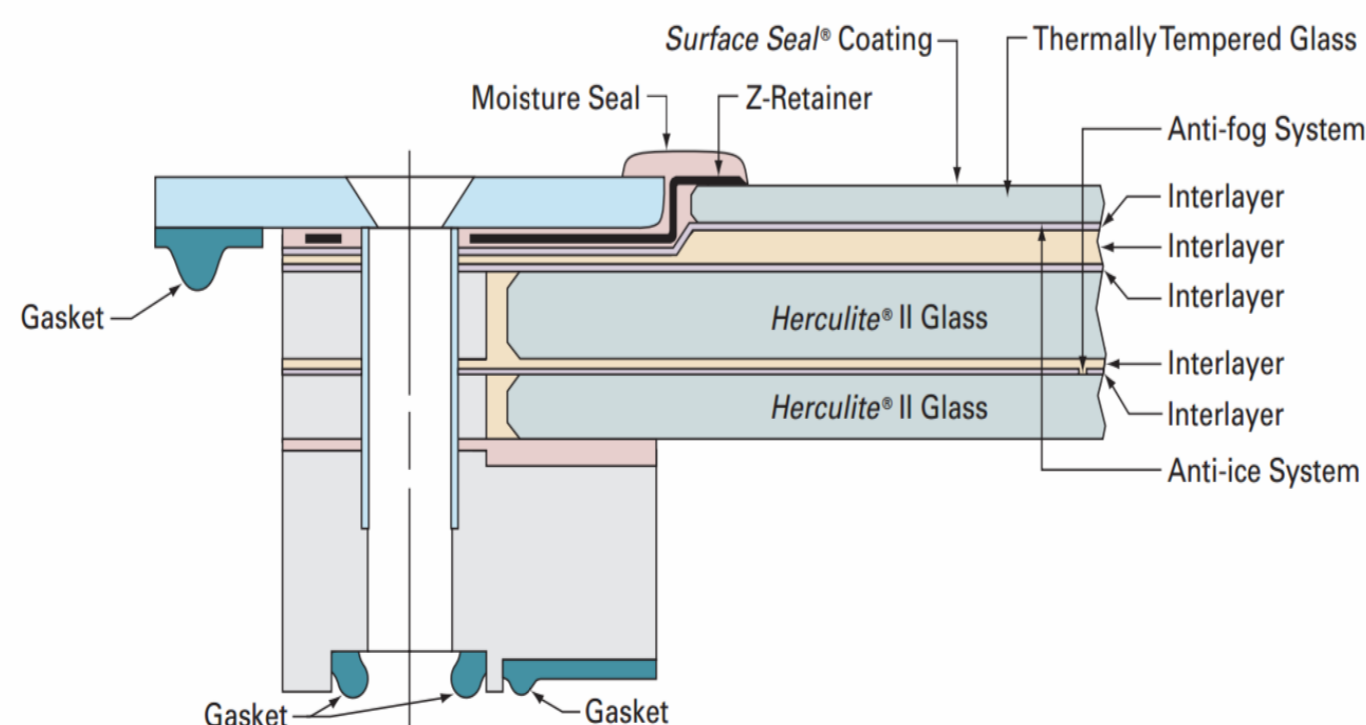
Main Windshield

As illustrated below, the windshield is made up of two inner panes of Herculite (chemically strengthened) glass and an outer pane of tempered glass bound together with urethane interlayers. On either side of the middle pane of Herculite and adjacent to the inner and outer panes are layers of Nesatron film. Nesatron is transparent but electrically conductive and heats up when a current is passed through it - the layers of Nesatron are the windshield heaters. The inner heater prevents fogging of the inner pane and the outer heater prevents both icing and contracting of the outer pane due to exposure to sub-zero air temperatures at altitude. If the outer pane wasn't heated it would suffer a "thermal break" and shatter which would then expose the middle pane.

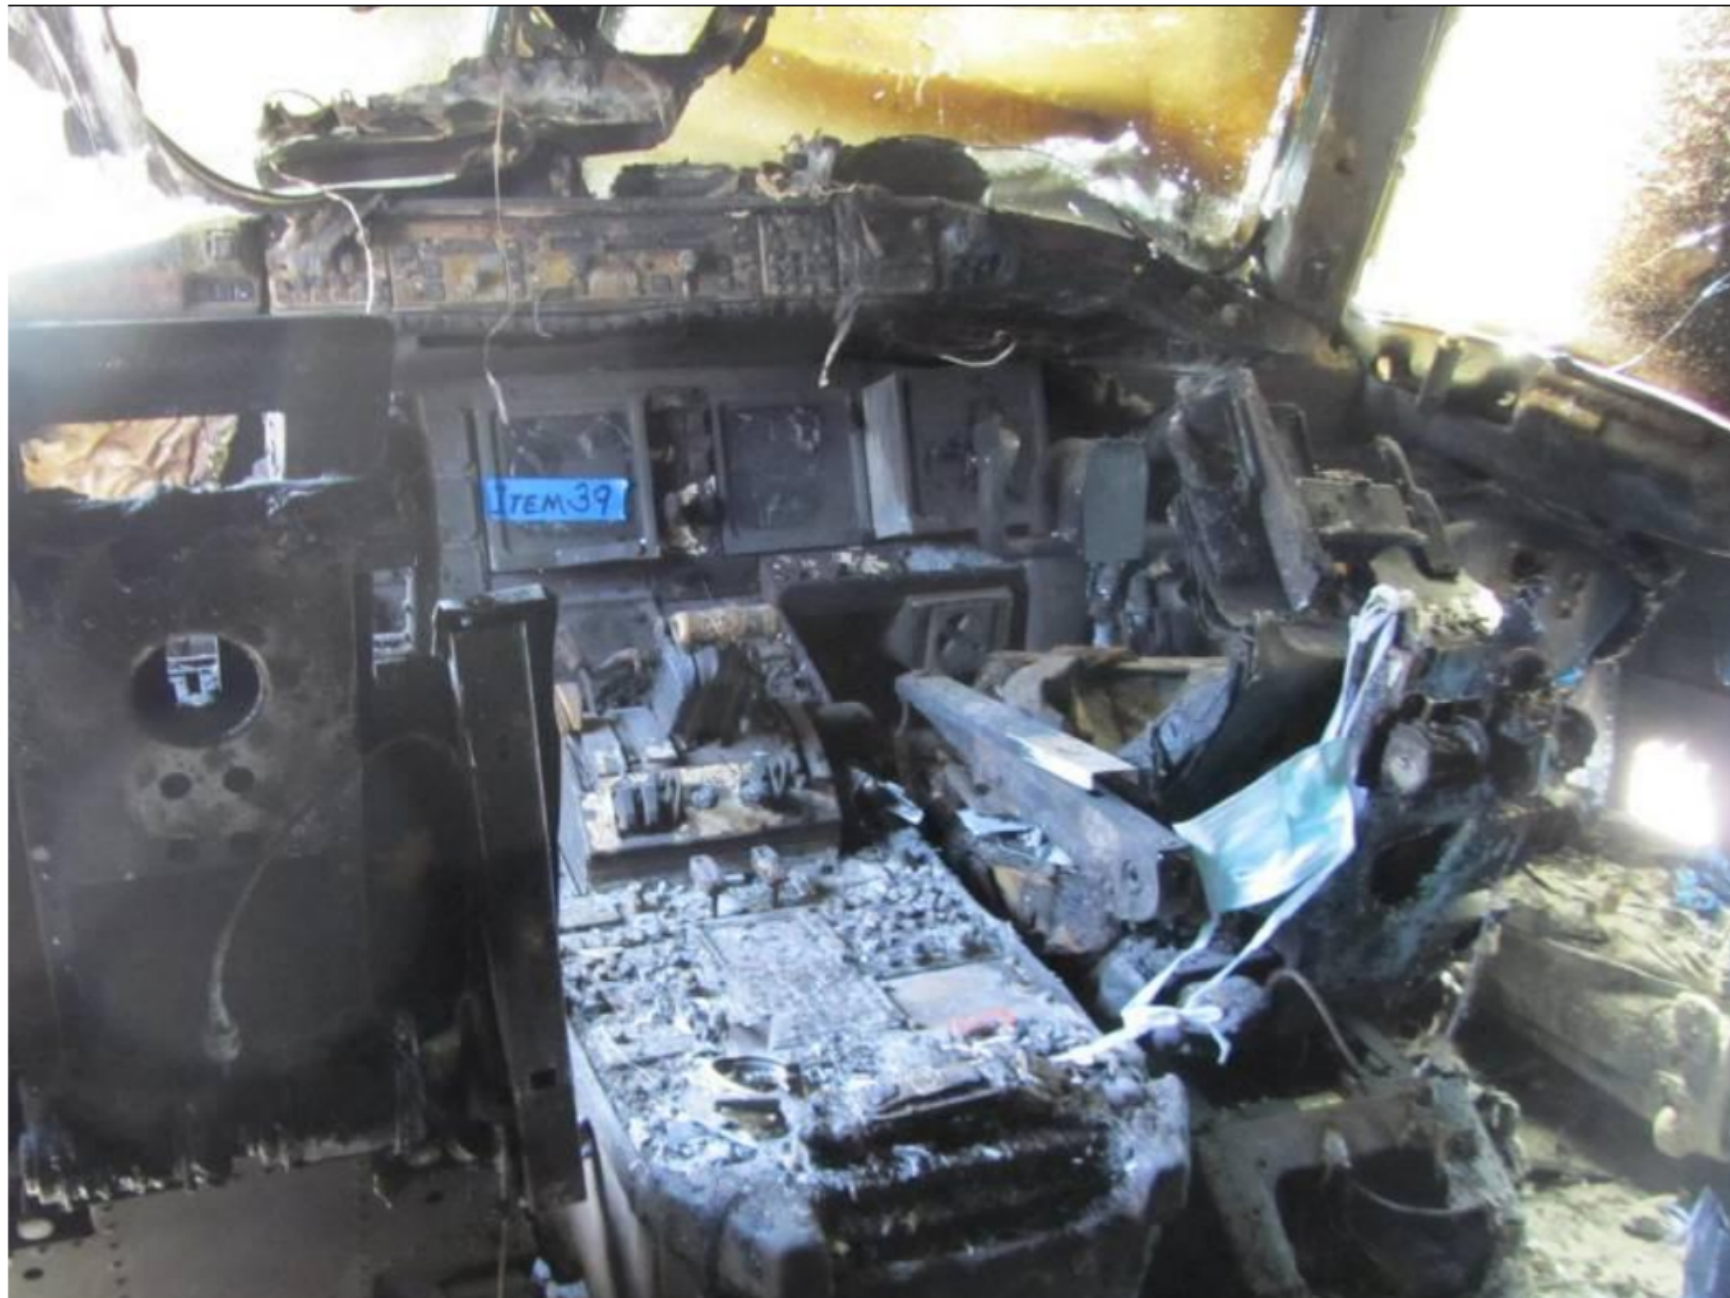
The photograph below is of the flight deck of an EgyptAir B777 that suffered an oxygen fire whilst on the ground at Cairo International Airport on 29 July 2011. It took less than 4 minutes for the fire to cause that damage. (As a matter of happenstance, the work that was done on 9M-MRO's crew oxygen system under FAA AD 2012-13-05 was a result of the findings and recommendations arising from the Egyptair B777 oxygen fire.)
