Air Safety Week

Nov. 25, 2002
Washington, D.C.

Vol. 16 No. 45
www.aviationtoday.com

Flight 587 Crash Case Covers Wide Range of Key Safety Issues

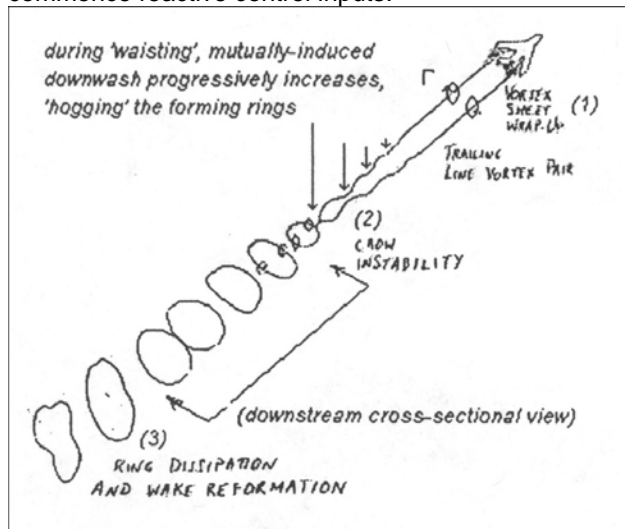
The Crow Instability Process

'An instant flurry would likely be the GO trigger to commence reactive control inputs.'

A trailing pair of wake vortices can merge into a series of vortex segments inclined more or less vertically. Hence, upon climb-out, a following aircraft at two-minute takeoff separation could encounter a preceding wake which is not a stable vortex pair, but which is in a state of breakdown or transition. Source: Brown, in NTSB Docket No. SA-522, Exhibit 2-X, Aug. 2002

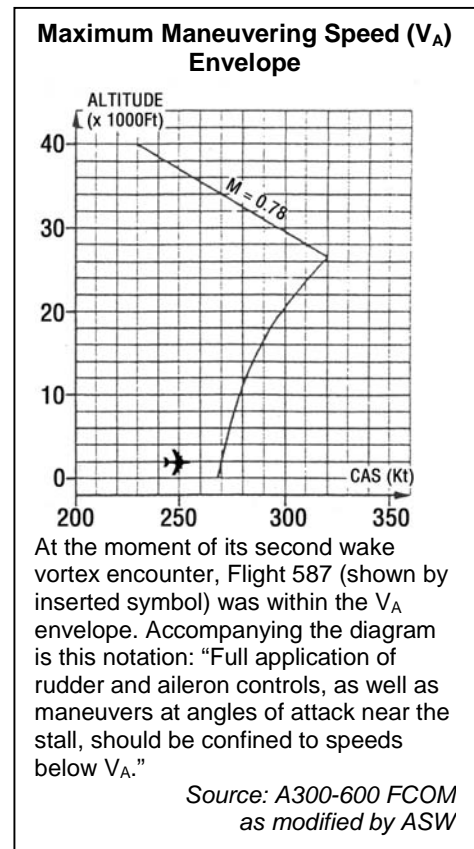
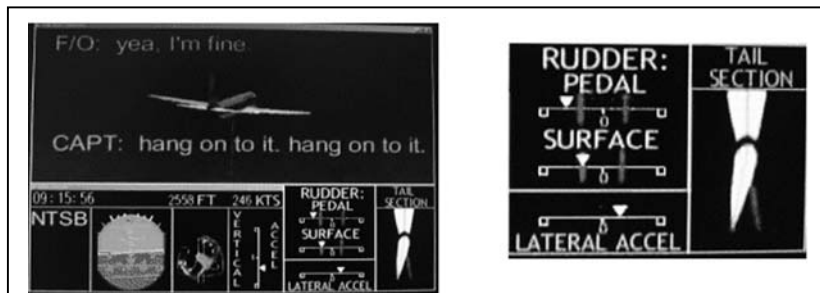
The rudder reversal before the “bang” sound on the cockpit voice recorder and the tailfin separated. Rudder pedal position is shown exceeding the movement limits, but the rudder travel is not. A later frame showing the rudder in a slightly out-of-bounds position may be an artifact resulting from the use of filtered data. The *unfiltered* DFDR trace of rudder position does *not* show it moving out of limits. Source: NTSB

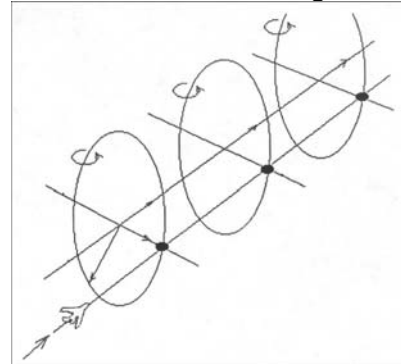
'Hammer Blows' From a Train of Vortex Rings

A following aircraft near the lateral edge of the vortex rings would encounter a series of reversing directional perturbations. The fin/rudder unsteady air loads accompanying the encounters are very short duration events.

In practice, it is likely they would be preceded by some initial wake turbulence, to which the pilot response may well be to 'ride through' without intervention – but which would conceivably 'key' the pilot towards an interventionary frame of mind.

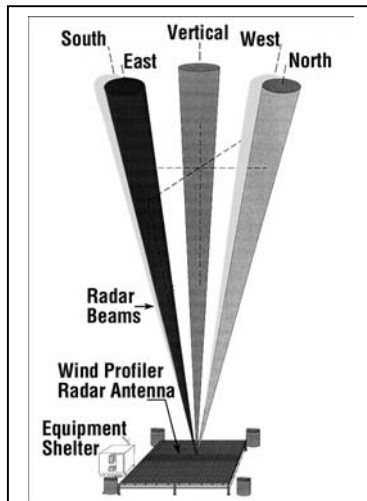
The UHF Doppler wind profiler produces vertical profiles of the horizontal and vertical wind by measuring the radial velocity of the scatterers aloft (rain, cloud droplets, ice crystals, refractive turbulence, etc.) as a function of range. Typical configuration, shown above, consists of one vertical beam and two to four tilted 15° from the zenith.
