# Swissair Flight 111: Investigation Overview

By Vic Gerden, P. Eng., IIC; Jim Foot, P. Eng., Systems Group chair; and  
Mike Poole P. Eng., Flight Recorder Group chair

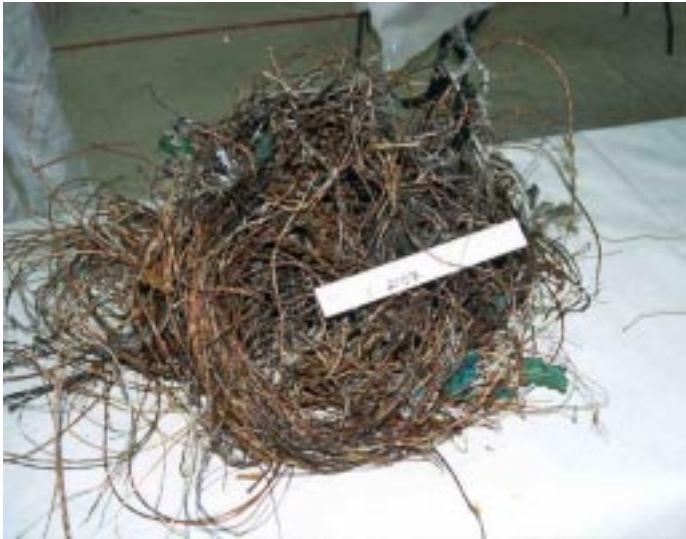
**Figure 1: Bundle of heat-damaged wires**

Heat-damaged wires were found early during the wreckage recovery stage (Figure 1).

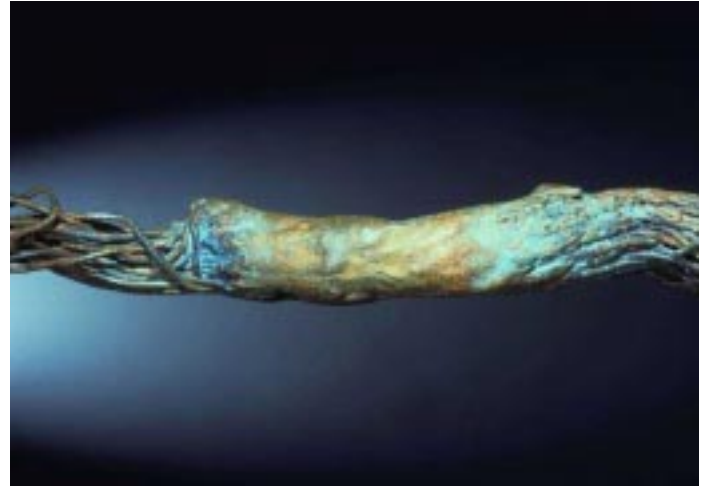
**Figure 3: Left emergency DC bus cable**

A total of 21 wires were recovered that exhibited copper melt damage. Of these, one was identified as the left emergency DC bus cable, and the melted copper was considered to have been the result of a brazing procedure during manufacture (Figures 3 and 4). The remaining 20 wires were considered to have been the result of arcing events.

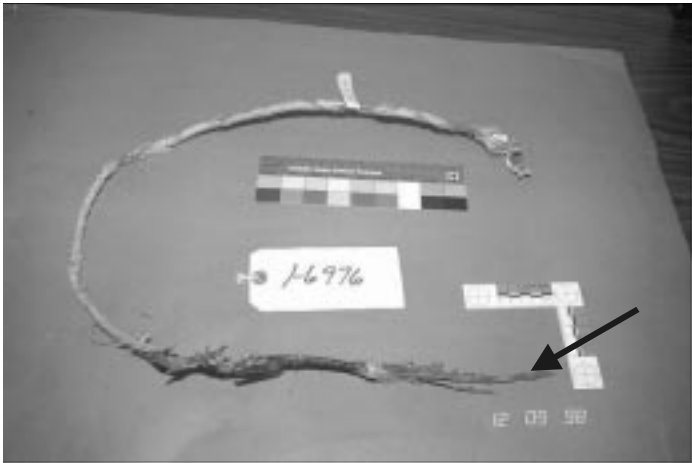
**Figure 4: Close up of Figure 3 (arrow) showing solid slug of copper considered to be from a braze operation during manufacture**

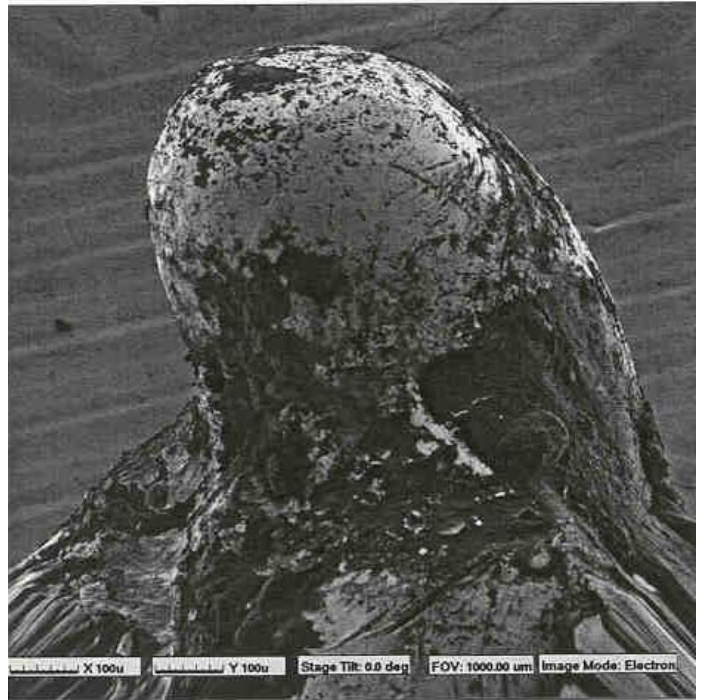
**Figure 5: Exhibit 1-10503, #16 AWG wire 5 inches long with copper bead caused by an arcing event**

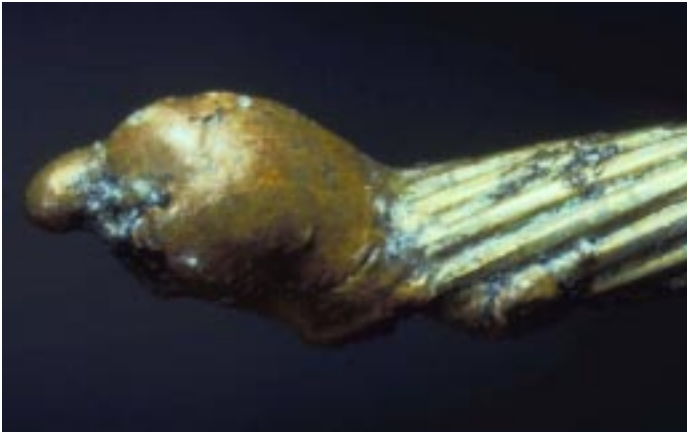
**Figure 6: Exhibit 1-10503, #16 AWG tin-plated wire showing location where a section was removed by focus ion beam mining for TEM analysis**

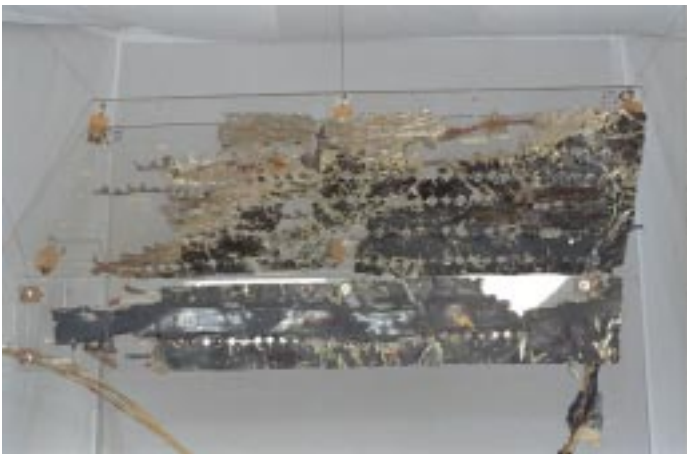
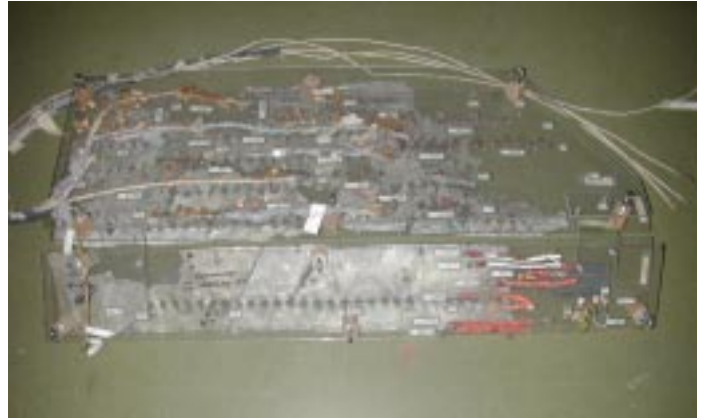
**Figure 7: Front view of avionics panel**

**Figure 8: Rear view of avionics CB panel**

The numerous small pieces identified as being part of the avionics panel were painstakingly reconstructed on plexiglass (Figures 7 and 8). This allowed the fire pattern to be assessed by virtue of the change in paint colour on the front of the panel and the loss of the insulation material on the bus bars on the back of the panel. The light plate assemblies from the front of the avionics panel (made from a thermal formable plastic) were also identified, and they were added to the panel in a further attempt to determine the heat patterns.

The reconstruction proved quite useful in documenting the heat pattern across the inboard side of the avionics panel. This, along with the missing bus bar insulation from heat on the outboard side, showed a pattern that gave credibility to the theory that some circuit breakers tripped from ambient heat. A circuit breaker will trip when the ambient temperature reaches approximately 177 C (350 F).

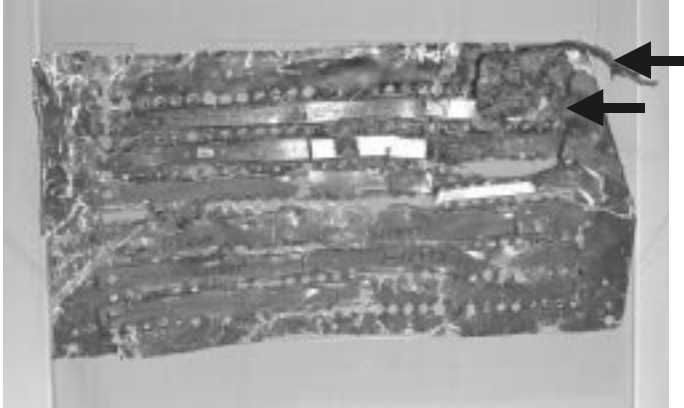
In the production aircraft, the overhead circuit breaker panel (Figure 9) is mounted in a fibreglass tub. A plexiglass mock-up of this tub was constructed, and the pieces making up the overhead circuit breaker panel were attached to it. This allowed the power wires to the busses, and numerous other wires that entered this area to be integrated into the tub in their correct orientation.

**Figure 9: Front view of overhead reconstructed CB panel. Arrows show location of melted light plate**

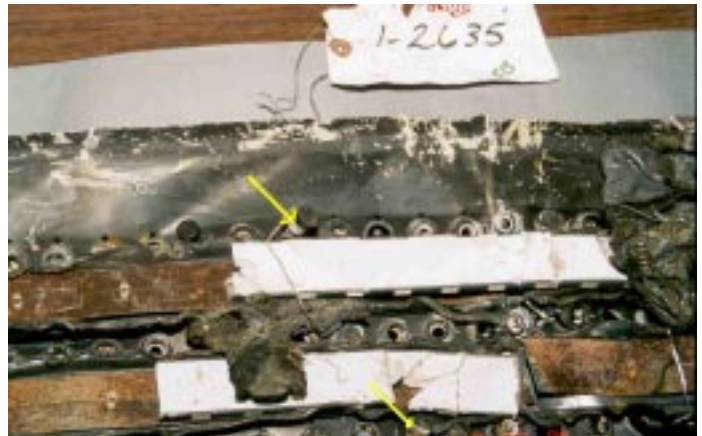
Some of these white rings were sooted, indicating that they had tripped prior to impact (Figure 10).

**Figure 10: Upper right corner of overhead CB panel showing CB white trip indicator rings clean (upper arrow) and sooted (lower arrow)**

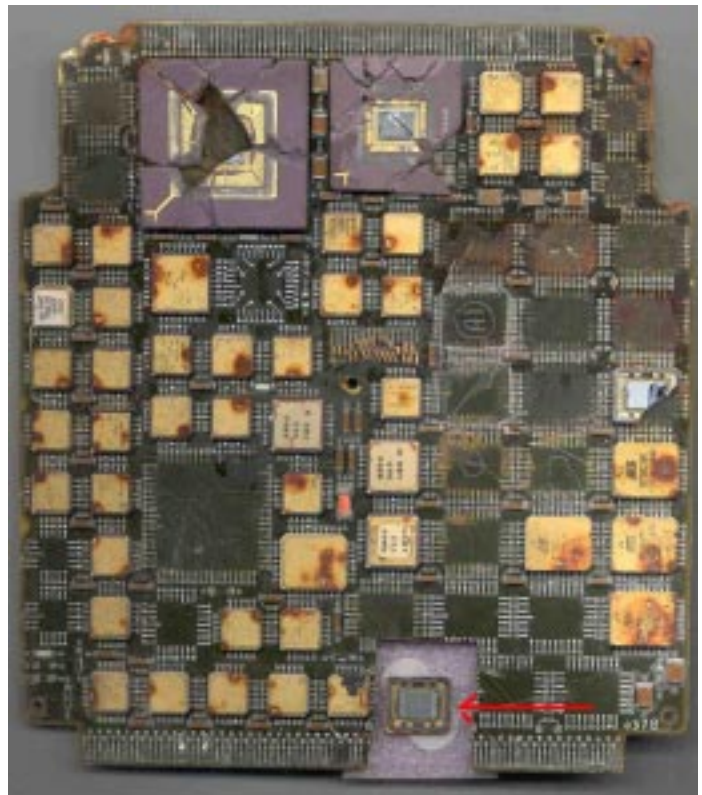
**Figure 11: FCC printed circuit board showing NVM chip already removed. Note extent of physical damage to remaining devices**

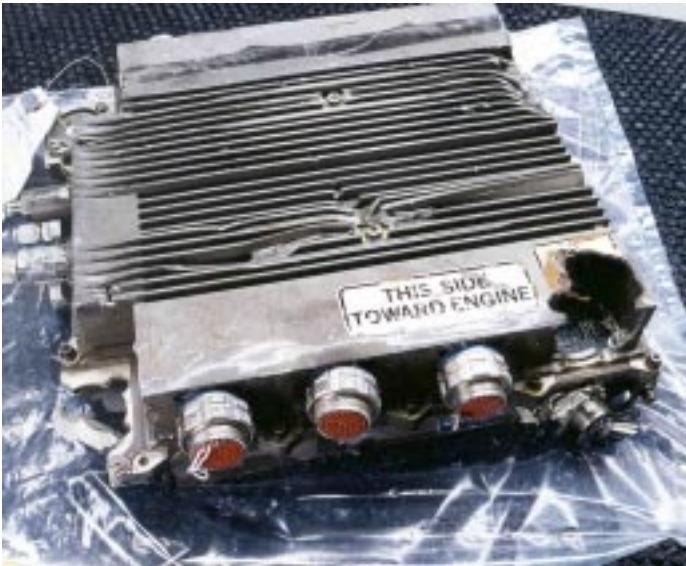
**Figure 12: FADEC electronic control for Engine 2**

The Pratt and Whitney PW4462 engines were equipped with full authority digital electronic controls (FADECs) that contained NVM (EEPROM) chips. The FADECs from Engines 2 and 3 (Figures 12 and 13, respectively) were recovered, along with the NVM chips, which were downloaded. Only pieces of the FADEC 1 were recovered, and the NVM chips had been stripped from their circuit board.

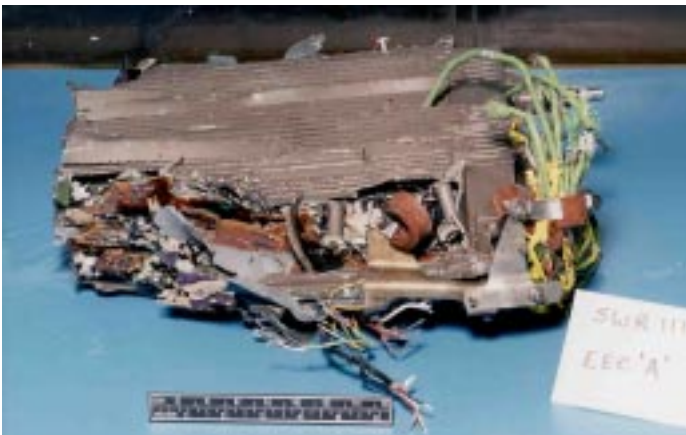
**Figure 13: FADEC electronic engine control for Engine 3**

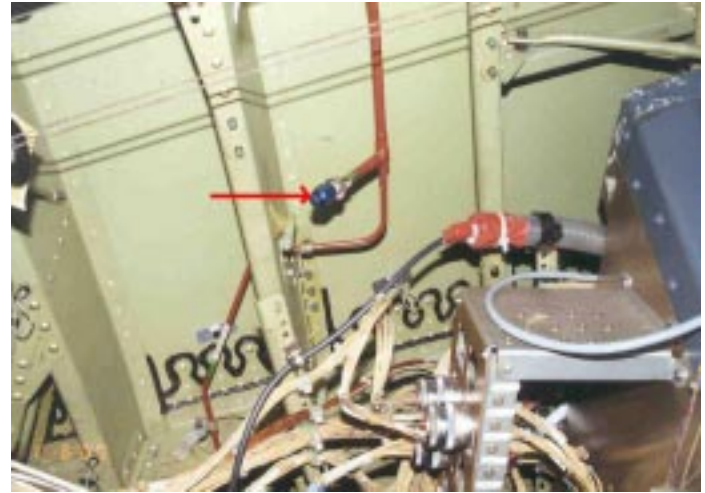
**Figure 14: Crew oxygen line above cockpit ceiling showing an AN929-6 aluminum cap on the end of a stainless steel fitting**

The crew oxygen line consisted of stainless steel tubing. It was routed from the oxygen bottle in the avionics compartment, up the left side of the aircraft, across the top of the cockpit ceiling, and then down the right side. Of particular interest was an aluminum AN929-6 cap attached to a stainless steel tube located above the cockpit ceiling (Figure 14). There was a possibility that heat could cause the aluminum cap to fail, depleting the oxygen to the crew and possibly aggravating a fire. The MD-11 uses stainless tubing in many areas, and it was not obvious which tubing came from the oxygen line. All of the recovered tubing was segregated and sorted, and those pieces that appeared to meet the material requirements for the oxygen line were further tested by energy dispersive X-ray analysis for material confirmation.
