Air Safety Week

April 7, 2003
Washington, D.C.

Canadian Investigators Decry Lack of Preparedness for In-Flight Fire *Swissair MD-11 crash probe reveals flammable materials, inadequate fire defenses*

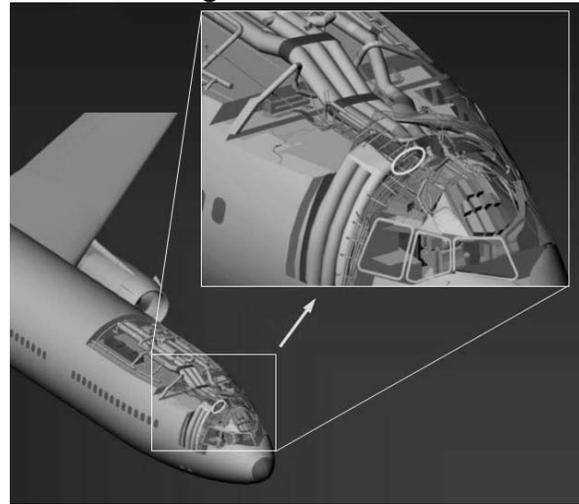
Origin of the Fatal Fire

Through reconstruction of the wreckage, Canadian investigators were able to pinpoint the location (small oval) of the electrical arcing that started the fatal fire in the attic space over the cockpit. This space has neither fire detection nor fire suppression.

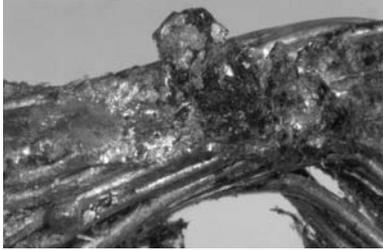
Arcing Damage Up Close

A 22x magnification of the arcing damage to the wiring powering the in-flight entertainment system on the accident aircraft. This arcing ignited adjacent flammable materials and triggered a cascading sequence of tripped circuit breakers and electrical system failures.
