Unplugged

A maintenance error caused oil to be lost from all four engines on a British Aerospace BAe 146 used to transport the Royal Family.

ON 6 NOVEMBER 1997, THE CREW of a UK Royal Air Force (RAF) British Aerospace BAe 146 shut down one engine and later another during an emergency landing at London Stansted Airport after indication of significant oil depletion.

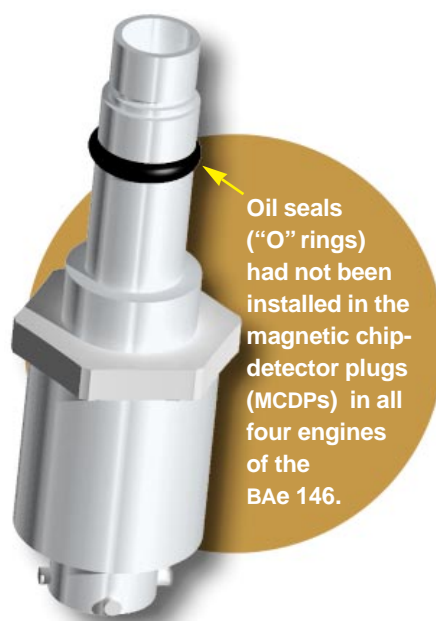
The UK Ministry of Defence said in its report that the incident was caused by maintenance error. The report found that magnetic chip-detector plugs (MCDPs) had been installed without oil seals ("O" rings) in all four engines of the BAe 146.

// The engine cowls were covered with oil, and oil spilled to the ground when the cowls were opened. //

The engine cowls were covered with oil, and oil spilled to the ground when the cowls were opened. The MCDPs were removed and found to have no seals.
