South African Civil Aviation Authority

SERIOUS INCIDENT

Probable Cause					
<p>During the take-off roll the captain applied an improper rotation technique by referencing the Side Stick Order Indicator to the 9° position on the Primary Flight Display. This caused the aircraft to de-rotate and not to lift-off as expected. When the aircraft over-ran the end of the runway with the associated noise, the aircraft was rotated further and became airborne with the application of Take-Off/Go-Around thrust.</p> <p>The training and mindset of the pilots could be considered as a significant contributory factor to this incident. They were "programmed" by tailstrike avoidance information, aircraft difference information and certain expectances to perform the way they did.</p> <p>A further contributing factor to the cause of this incident could be considered as the differences in take-off performance of the different Airbus aircraft of the operator's fleet.</p> <p>A further contributing factor to the cause of this incident was that this was both flight crew members second flight in the actual aircraft of this variant of the Airbus A340 (Captain's first flight as pilot flying).</p>

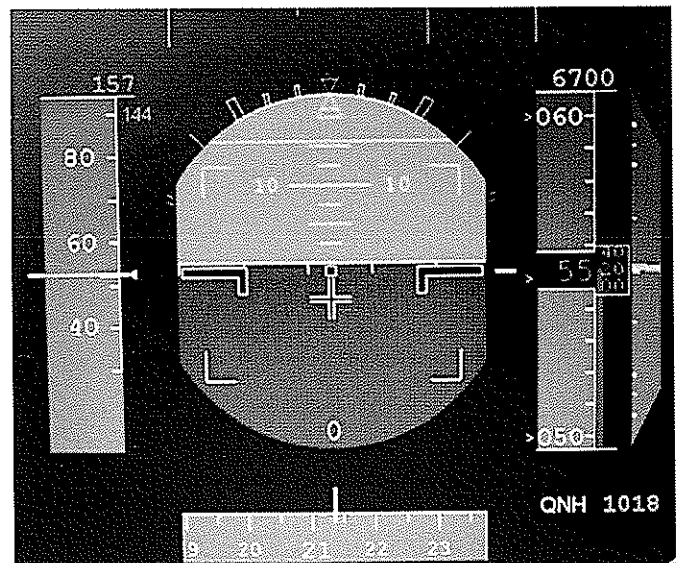
The Captain maintained the aircraft on the centreline as it accelerated, with the First Officer monitoring airspeed, the engine instruments and the centreline tracking, etc. During the initial ground run the PF applied a forward stick control input as described in the Flight Crew Operating Manual to counter the nose up effect of setting engine takeoff thrust to about 80 knots. At 75 knots the Side Stick Order Indicator (SSOI) started moving back to the centre position as the PF centralized the sidestick. As the aircraft approached 144 knots the

First Officer called "V₁" and this was reiterated by the auto call-out. At 152 knots the First Officer called "rotate". The Captain stated that, at this point he went fully onto instruments, to ensure the rotation was as accurate as possible. His understanding of the new technique was to achieve 2/3 back stick, by bringing the stick rearward at a measured rate, over three seconds. This he achieved by cross-referring to the SSOI and finally placing the SSOI at +9° on the Primary Flight Display (PFD) pitch scale, to initiate rotation and to maintain this, to get the aircraft airborne. Thereafter to follow the flight director Speed Reference System (SRS) pitch command.

Recorded data shows that, in initiating the rotation, the Captain applied rearward side-stick such that the SSOI, displayed on the PFD indicated +9° and that, after approximately 4 seconds the aircraft nose started to move upwards at a normal rate. When asked to explain this method of initiating the take-off, the Captain said that he was using this technique, having been made aware of it in his refresher training that he had completed in March. During a lesson to standardize rotation techniques across

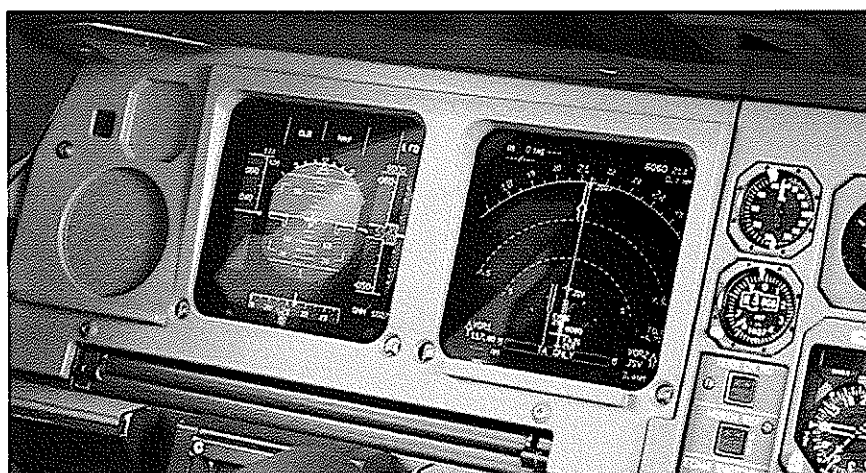
1.6.8 The aircraft's cockpit instrumentation was of the "glass cockpit" type lay-out (refer to photograph above). The Primary Flight Display (PFD) is the display panel on the left-hand side in the photograph. This display provides the pilot with mainly attitude information during operation of the aircraft. The basic layout of the Primary Flight Display is as indicated on the schematic to the right-hand side.

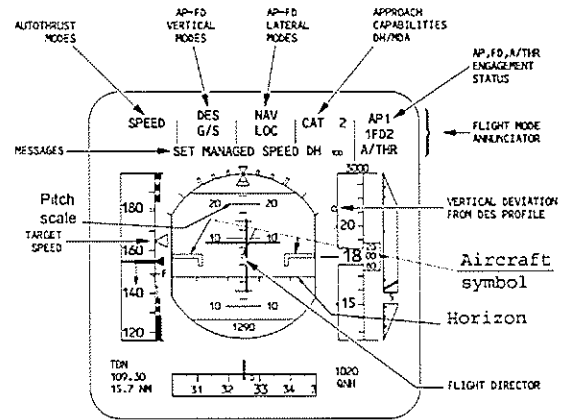
1.6.9 Due to the lack of mechanical inter-connection between the two side-sticks, the manufacturer incorporated a Side-Stick Indication display on the PFD's of both pilots. The Flight Crew Operations Manual (FCOM) (1.27.40) describes the Side-Stick Indications on the PFD, as "On ground, after first engine start, side stick position indications appear white on both PFD's. The indication disappears when the aircraft passes from "ground" to "flight" mode.

The schematic (to the right) shows the Side Stick Order Indicator (SSOI) as a small double-line cross \oplus representing the combined left and right side stick position, with the 'corners' of the maximum deflection envelope at the extremes of available travel, approximately 16° in pitch and approximately 20° in roll (FCOM 3.04.27). However, the 16° of travel does not correspond to 16° on the pitch scale of the attitude indicator on the PFD. The SSOI, "...permits the PNF to check that the PF is making an appropriate control input during takeoff roll" (FCOM 3.04.27). The SSOI \oplus disappears, once the aircraft attains the "flight mode", through the main landing gear air/ground switching. Any given rearward deflection of the side-stick will cause a relative upward displacement of the SSOI on the PFD. Whilst the aircraft is level on the ground, this will equate to a specific number of degrees above the horizon on the pitch scale of the attitude indicator. However, as soon as the aircraft pitch attitude changes (during rotation for example), the displacement of the SSOI, though constant in relation to the travel limit marks and the side-stick, will appear to increase in magnitude in relation to the pitch scale. This is because the horizon line and the pitch scale have moved down the PFD, while the SSOI remains referenced to the fixed travel limit marks.

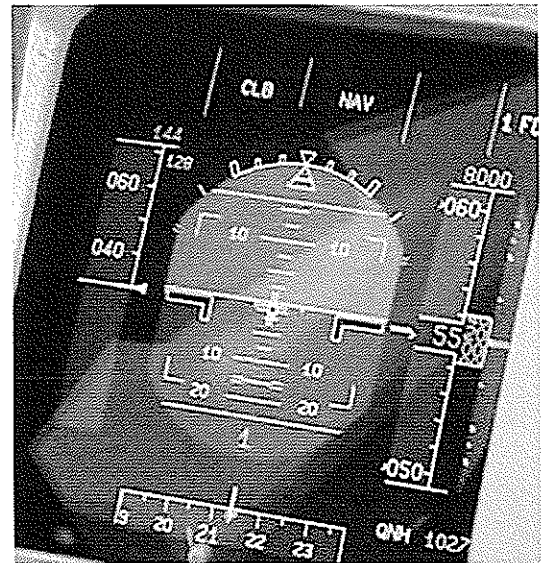
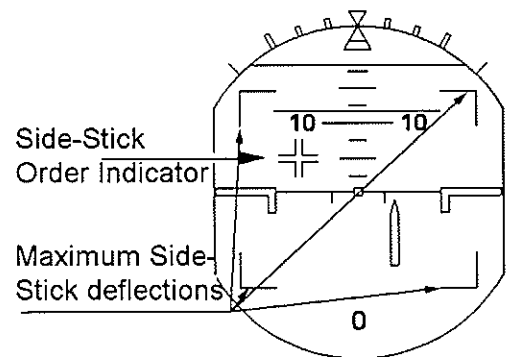
In summary, the pitch scale of the attitude indicator of the PFD is not a quantitative indication of side-stick movement and has no constant relationship to side-stick deflection and SSOI displacement.

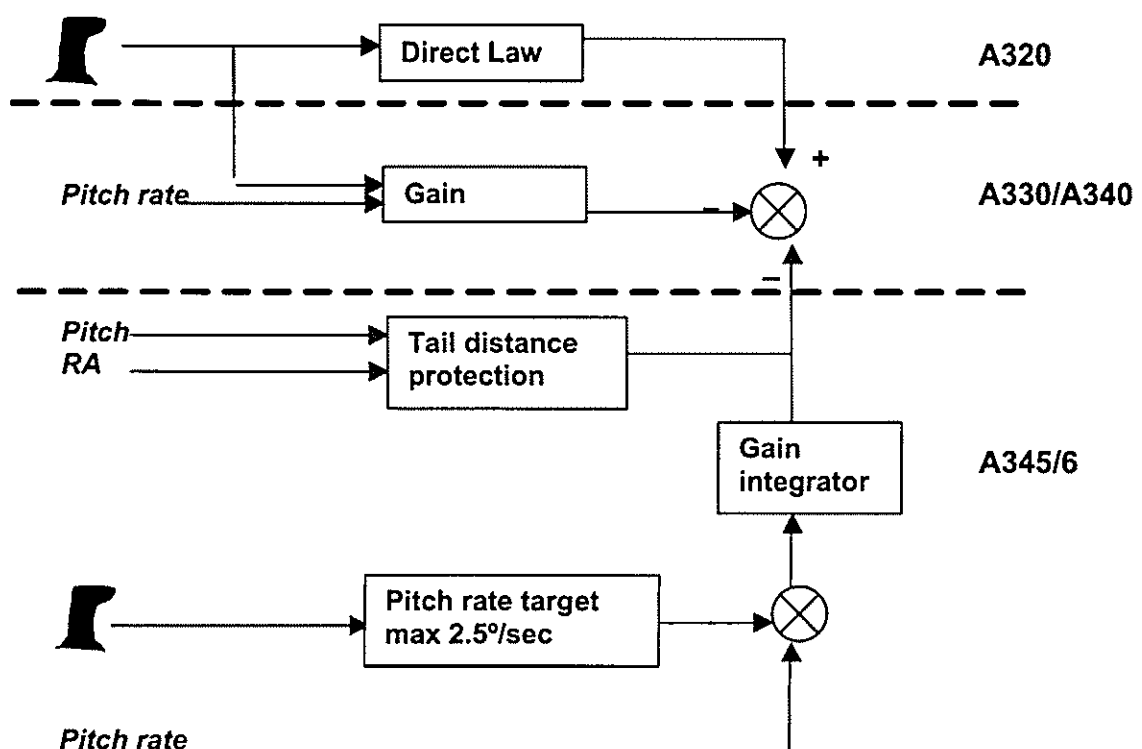
The pitch control law of the A330/A340 has been adjusted to the size, the inertia and the tail-strike tendencies of each aircraft. Refer diagram below.

Basically the take-off rotation law is a direct law, which has been damped essentially on A330, and all A340s by a pitch rate return which acts on the elevator deflection when the pitch rate increases.

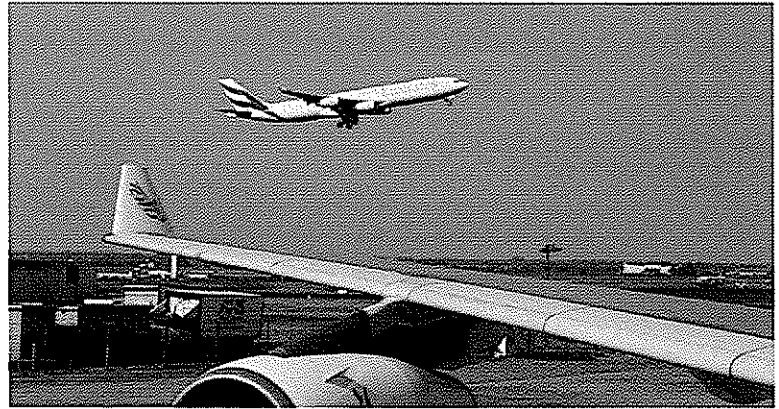
After the test flight the investigator and flight crew observed another Airbus A340-300 of the operator take-off on the same runway as the aircraft used during the incident. The aircraft rotated and was airborne approximately three quarters down the runway. It further climbed and reached approximately 150 to 200 feet by the time it reached the

end of the runway. It was unknown what the load, power setting and other parameters of the take-off for the observed aircraft was, but the captain who flew the test flight commented that the aircraft taking-off is displaying the typical take-off profile that they had planned for these aircraft.
