Air Safety Week

May 5, 2003
Washington, D.C.

Task Force Backs Training to Improve Aircraft Wiring Safety *Cost of new wire inspections may limit them to voluntary compliance*

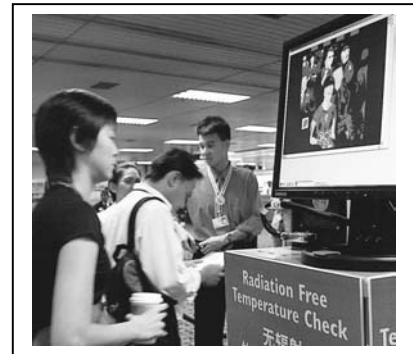
• **Thermal screening.** Outbound travelers at Singapore's Changi Airports as well as inbound passengers from SARS-affected countries must pass through a thermal scanner, reports the **Singapore Tourism Board** (*see photo*). The scanners are used to take the temperatures of passengers before they pass through immigration checks; medical staff examines inbound passengers who have an elevated temperature and outbound passengers with a temperature must provide a doctor's certificate that they are not suffering from SARS before being allowed to fly. ■
