# Air Safety Week

Nov. 18, 2002  
Washington, D.C.

## New Jackscrew Design Increases Safety Through Redundancy

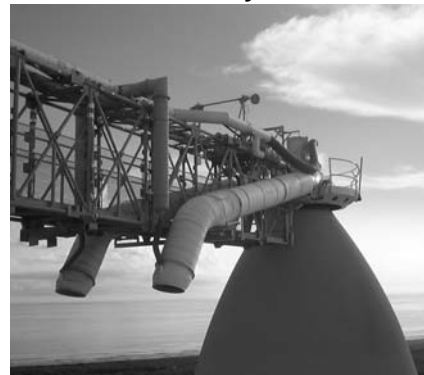
A failsafe jackscrew ensures that the uppermost service arm for the Space Shuttle and its associated oxygen vent hood moves away from the external tank, shown here, moments before launch. The tank is loaded with liquid oxygen and liquid hydrogen. If the jackscrew should fail when the vent hood is rotated, first up and then away, it could collapse onto the tank with catastrophic consequences. The failsafe jackscrew has numerous applications for aircraft. Photo: KSC

Engineers at Florida's **Kennedy Space Center** (KSC) have designed a jackscrew mechanism that adds a follower nut. According to a September 2002 KSC technical bulletin, the failure of a jackscrew used during Space Shuttle launches provided the stimulus for a fail-safe design. At the end of the uppermost service arm to the Space Shuttle, a jackscrew rotates the oxygen vent hood upwards, away from the Shuttle's main fuel tank, just moments before launch. Once rotated upward, the arm and attached vent hood are swung

away from the Shuttle to a safe position for launch. Should a jackscrew structurally fail during the vent hood rotation, the hood could crush the expendable fuel tank, which is loaded with liquid oxygen and liquid hydrogen. Such a failure would be catastrophic (e.g., the ruptured tank could explode). "A fail-safe design was needed to mitigate the possibility of such a single-point failure," according to the KSC technical note.

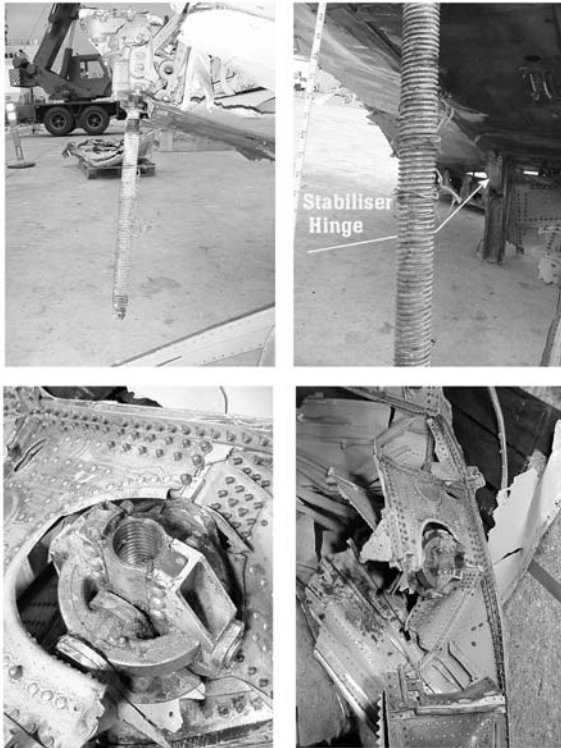
**Alaska Flight 261 and Single-Point Failure**

Broken jackscrew (upper two frames) and acme nut (lower two frames) assembly from the Alaska Flight 261 accident aircraft. The worn threads in the acme nut left the jackscrew with nothing to grip, leading to separation of the horizontal stabilizer and loss of control in flight.

protection against catastrophic failure. But if the acme nut failed, the redundancy built into the jackscrew was irrelevant. **Boeing** [BA] engineers asserted that the two threads machined into the acme nut represented two independent and therefore redundant load paths. However, the engineers were at pains to describe a scenario in which damage to one thread would not affect the other. As it turned out, the threads on the acme nut from the accident aircraft were worn almost completely down. To the touch of a finger, they felt like slight bumps. In other words, no threads, no redundancy.

With the acme nut threads sheared to a nubbin, there was nothing to hold the elevator in position; it flipped up like the tailfin of a whale just before it dives. Like a piece of plywood in a hurricane, the stabilizer promptly broke off in the airstream. With no control over pitch, the airplane flipped end-over-end as it plummeted to its doom.

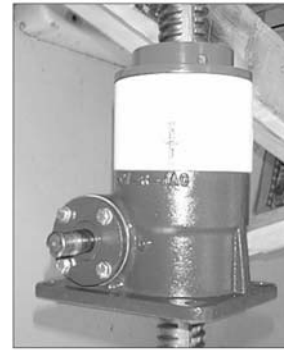
**The Failsafe Continue-to-Operate Jackscrew**

The assembled jackscrew

The design features a piggybacking secondary threaded nut that “follows” the primary and carries the feedback instrumentation device for checking and alerting on wear tolerance of the load-carrying primary. It can also act as a backup load-carrier in the event of a primary thread failure – via the castellated interlock. The stabilizing presence of the secondary nut may actually reduce the rate of wear over a limited threaded mating surface (lack of lubrication over this limited surface also can aggravate the wear rate). The backup arrangement may actually increase the threaded mating “run,” although the primary nut remains the sole load-carrier (short of its failure).

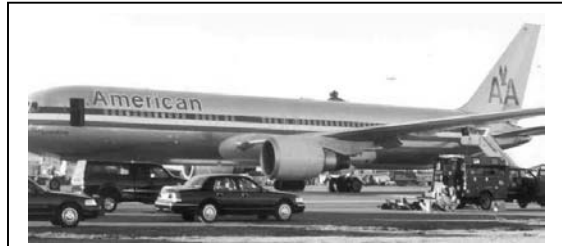
At right above is the state police bomb unit's vehicle, with gear, including a remote-control bomb disarming robot, deployed behind the tailgate. Photo: Massport
